## INFLUENCE OF MnS INCLUSIONS IN STEEL PARTS ON FATIGUE RESISTENCE

This paper presents examinations, checks and tests made on train axles in order to establish the mechanism and causes resulting in breaking after a short period of operation. Researches included analyses onto breaking surface and adjacent area of this, consisting in macroscopic visual examination, microscopic examination of fracture surface of the material and its adjacent area by optical stereomicroscopy and scanning electron microscopy (SEM) at low magnification and investigation of the material by energy dispersive X-ray microanalysis (EDX) for micro scale composition.

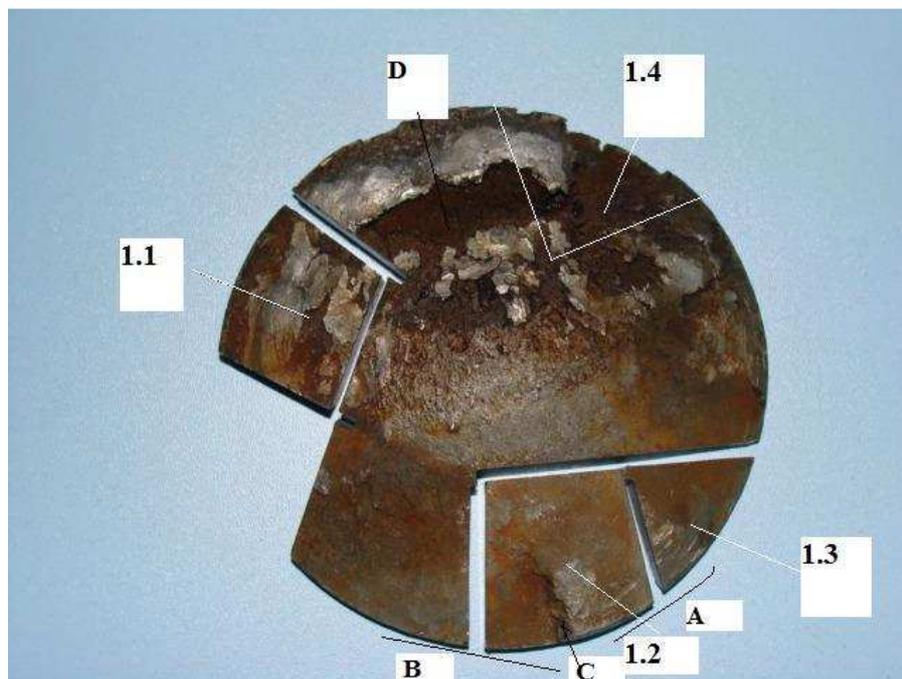
**Macrovisual examination of fracture surface** of axle shaft shown in figure 1 presented fracture surface, composed from fragments (samples), cut from the section of shaft in the form of a disk, containing the fracture surface.

*Fig. 1. Aspect of fracture surface of axle shaft*

Fracture surface aspect is characteristic of a fatigue fracture process with multiple primers. Damage of both breaking surface and edge breaking surface (outside the zone) that took place during the train accident event or in the process of sampling and evidence preservation does not allow clear identification of the percussion break.

Surface aspect suggests that the initiation of the breaking process had appeared first in area A (very damaged) and then in area B.

Both breaking processes met in the threshold C, which separates them through level differences. Towards zone D, fracture surface becomes more uneven, which suggests the fracture

propagation speed increases until the zone D, where the final rupture took place, with uprooting of material.

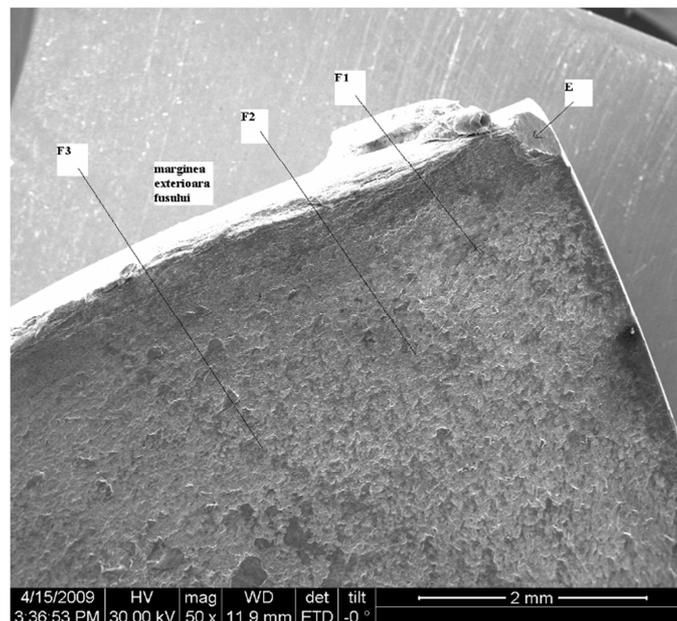
Scanning electron microscopy image (Figure 2) shows a part of the fracture initiation from zone B. In point E (probably one of the primers) existence of visible mechanical damage prevents identification of the primer. We can see the existence of fronts F1, F2, F3 of changing the propagation fracture rate, characteristic of a fatigue fracture. The edge zone corresponding to circumference of the shaft is deformed mechanically, on a depth of about 0.3-0.4 mm (probably after the rupture on shaft axle) showing cracks and even separation of material to the inner area of the breaking surface.

*Fig. 2. Microscopic image of the fracture initiation zone*

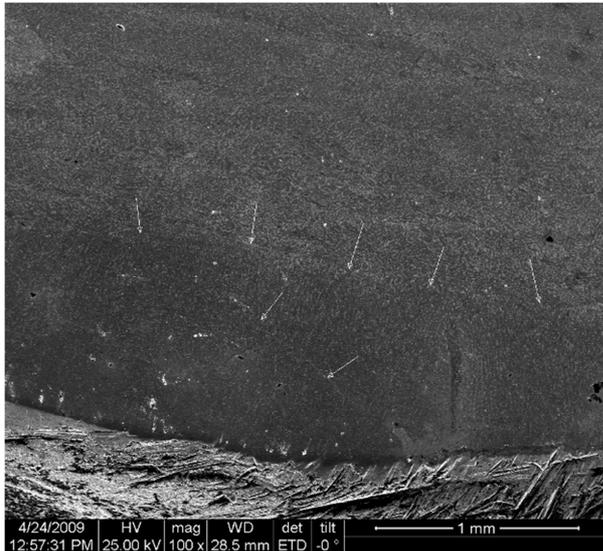
In figures 3, 4 and 5 we can clearly see microstructure details of the micro – area presenting a variation in diameter of the axle shaft in the breaking zone. Marginal area which corresponds to the narrow zone of the section presents characteristic microstructure aspects of a region with local molten material, with the ferrite – pearlite grains growth directions perpendicular on the longitudinal axis of the axle.

Solidification fronts are seen and the existence of micro – cracks in the material from this micro – area.

*Fig. 3. Marginal area, highlighting areas of molten material. Arrows indicate the start of the front lines of solidification*

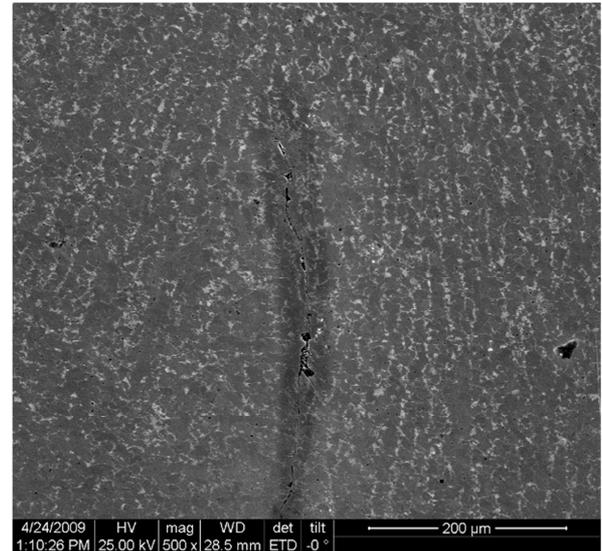
*Fig. 4. Crack parallel with the solidification temperature gradient. Is observed the oriented nature of the material solidified structure*

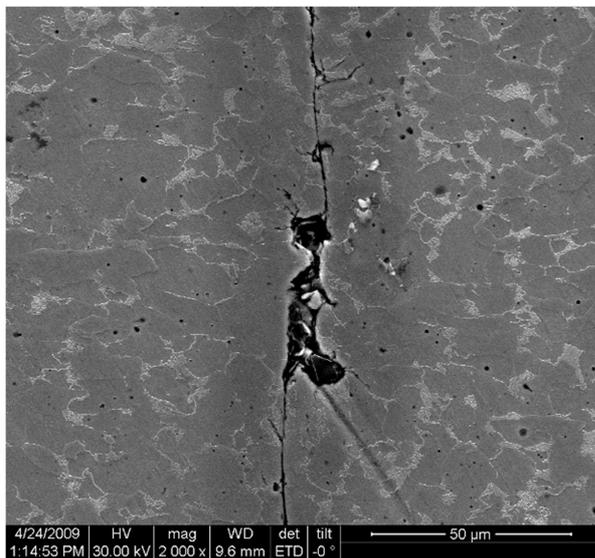
*Fig. 5. Emphasizing higher-order enlargement of the crack propagation intragranularly.*

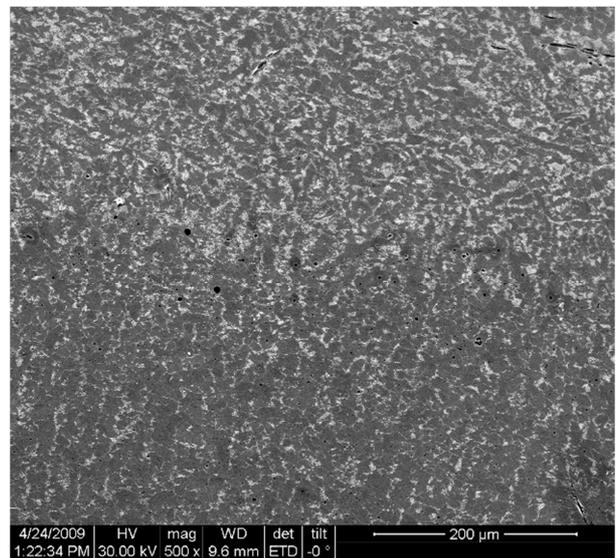
*Fig. 6. Image obtained on the transition from the base material to the molten material.*

In figure 6 we can observe the orientation differences of the structural formations but also a lower proportion of pearlite in the molten area (due to loss of carbon). We can also observe pores and micro inclusions at the interface between the two volumes of material.

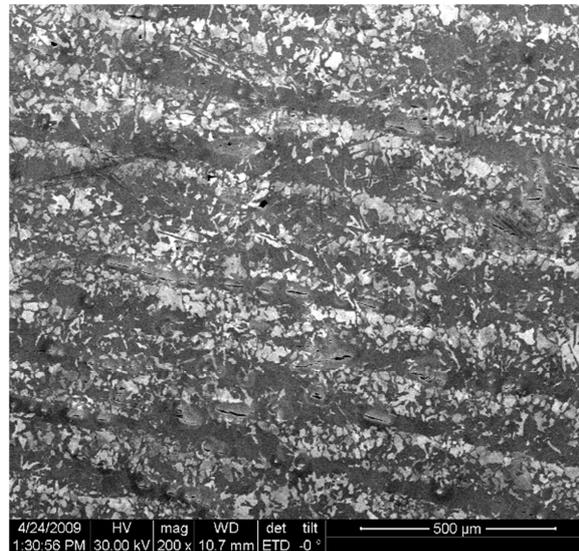
The axle shaft base material microstructure is shown in figure 7 and 8. The microstructure is oriented in bands, rich areas in pearlite alternating with the areas in ferrite. Also are observed the MnS plastic inclusions elongated in the direction of deformation.

*Fig. 7. Microstructure from the base material of the axle shaft.*

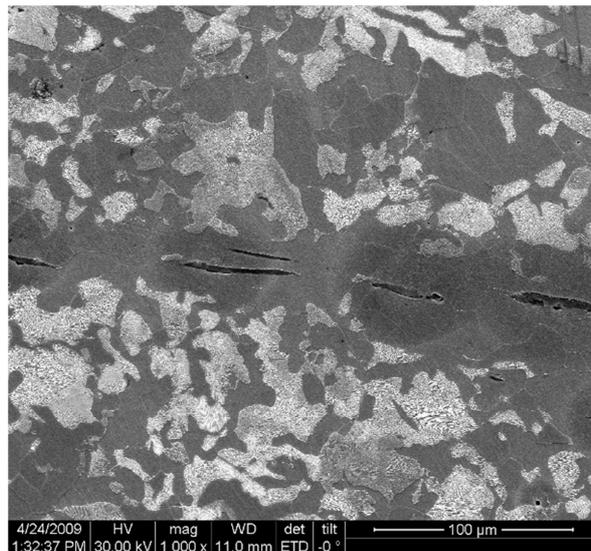
*Fig. 8. Detail of image shown in fig. 7. Inclusions arranged in the direction of plastic deformation.*

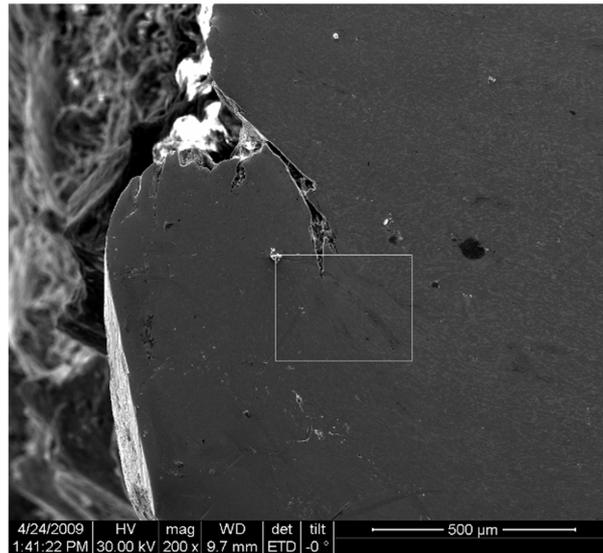
In the thicker zone, is observed a folded of material (on the circumference of the zone) to the fracture surface (figure 9). Scanning electron microscopy images from the figure 10 and 11 reveals clearly elongated microstructure (flow) to the fracture surface.

Fig. 9. „Folding” of material observed near the fracture surface.

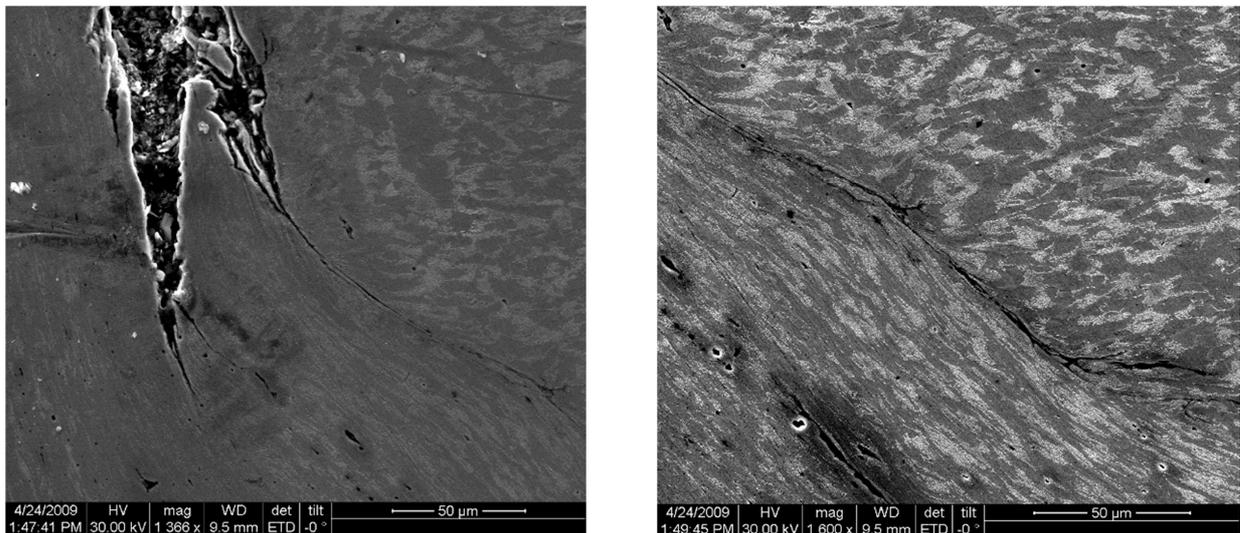
Fig. 10. Details of the selected area in the image of fig. 9 – volumes of material with different flow directions.

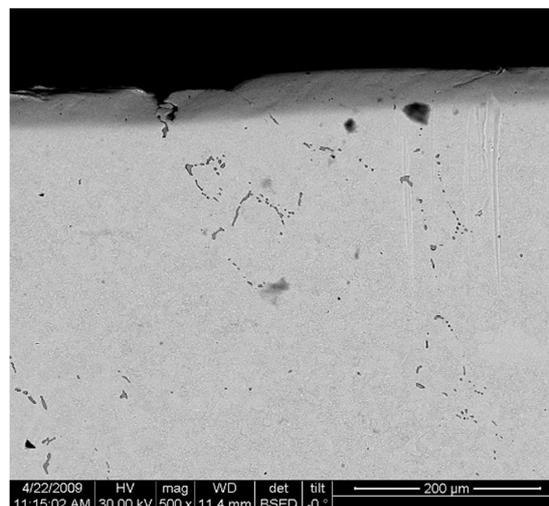
Images from figure 12 – 15, are images of secondary electrons, presents the material microstructure obtained on the sample 2.1, from figure 11. The existence of MnS inclusions unevenly distributed in the material is remarkable, on the ferrite-perllite microstructure background. Unfavorable to its mechanical properties, these inclusions are typically grouped in discontinuous networks. We observed also the rows of MnS inclusions existence, which arrive in the axle shaft surface. Such marginal inclusions may be percussion break of those parts that are in service, rows of inclusions that emerge in the area are preferred regions of propagation and development of microcracks.

*Fig. 12. Microstructure of axle shaft (image of secondary electron), cross section on shaft. MnS inclusions in both isolated and discontinuous networks, number of inclusions MnS come out in the outer edge of axle shaft.*

a) existence in the cross section of shaft of the discontinues networks of MnS inclusions, negative factor for the mechanical properties of the material;

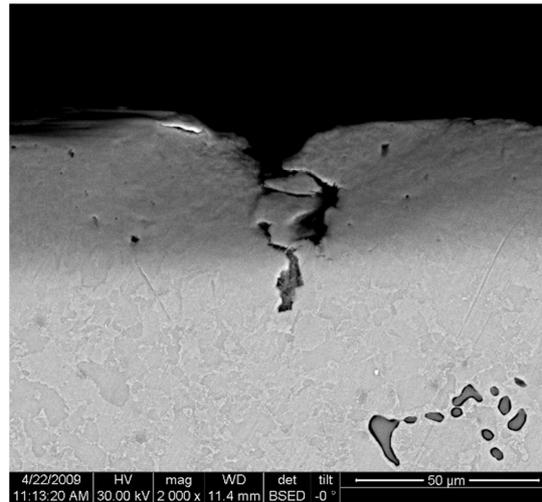
*Fig. 13. Detail from fig. 10a- edge corrosion primer on the sequence on MnS inclusions.*

b) existence inclusions rows (observed in transverse section on shaft) that emerge in edge. This may be primers of breaking and corrosion primer of the material.

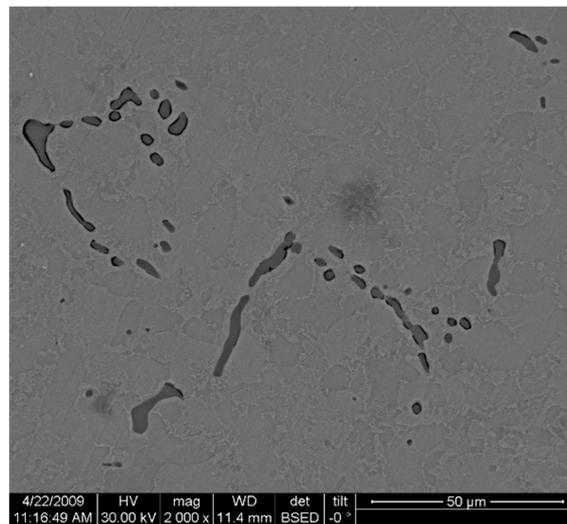
*Fig. 14. Detail from fig.10a-discontinuous network of MnS inclusions.*

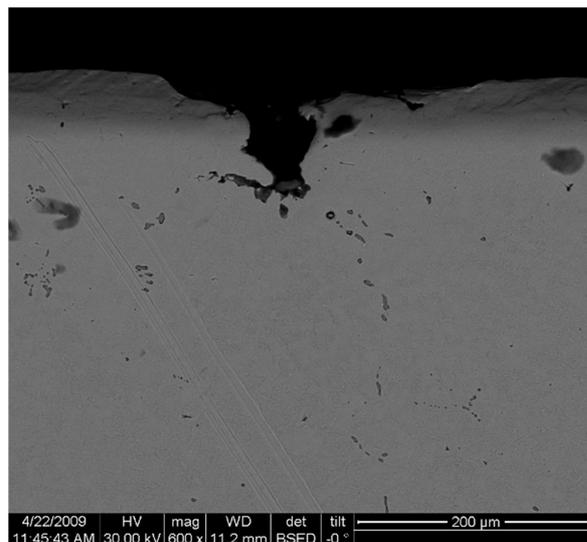
*Fig. 15. Aspect of another edge micro area with corrosion initiated on a network of inclusions.*

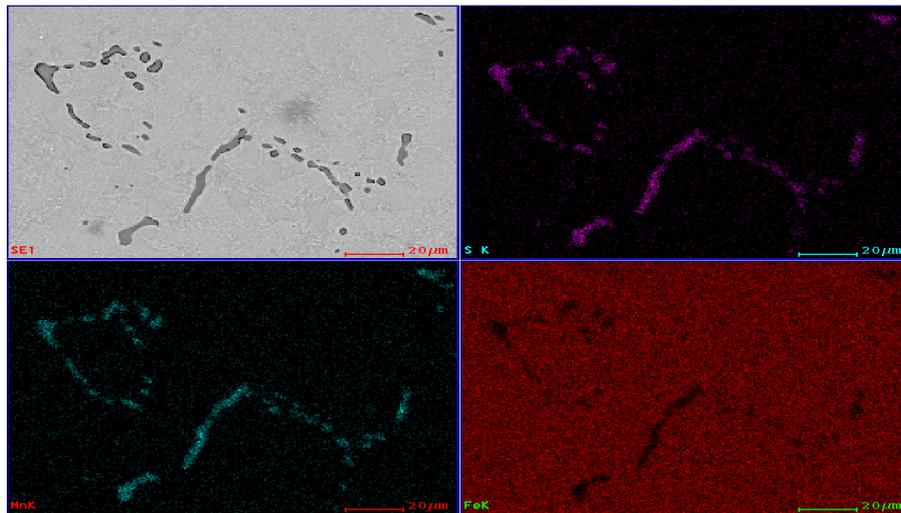
In this way in figure 16 is presented the elements distribution like Mn, S and Fe in the micro area shown in the left up corner of the image. It is observed the majoritary presence of the Mn and S elements in the elongated inclusions (manganese sulfide).

Fig.16. Elements distribution of Mn, S and Fe in the micro area shown in the up left corner

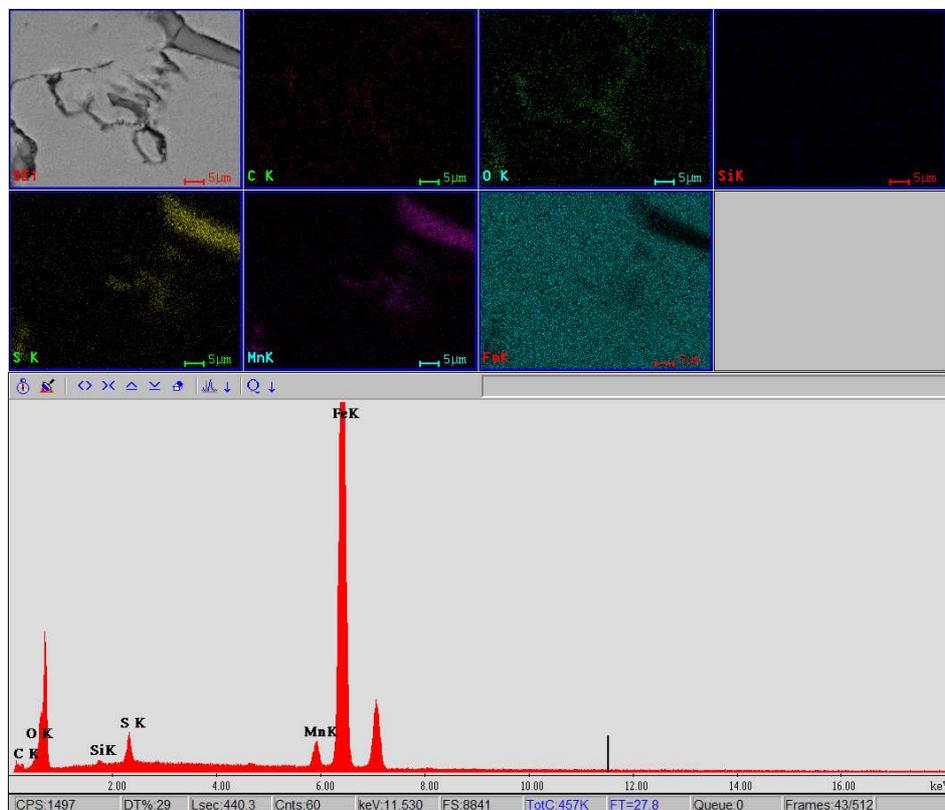
Images in figure 17 demonstrate the microcracks strings and networks start and developing are favored by the MnS inclusions.

Fig. 17. Elements distribution revealed by the EDAX spectrum in the micro area from the upper left corner. Micro area is adjacent to the breaking surface and corresponds to sample 1.4 (fig.1)
