## INFLUENCE OF MnS INCLUSIONS IN STEEL PARTS ON FATIGUE RESISTENCE

This paper presents examinations, checks and tests made on train axles in order to establish the mechanism and causes resulting in breaking after a short period of operation. Researches included analyses onto breaking surface and adjacent area of this, consisting in macroscopic visual examination, microscopic examination of fracture surface of the material and its adjacent area by optical stereomicroscopy and scanning electron microscopy (SEM) at low magnification and investigation of the material by energy dispersive X-ray microanalysis (EDX) for micro scale composition.

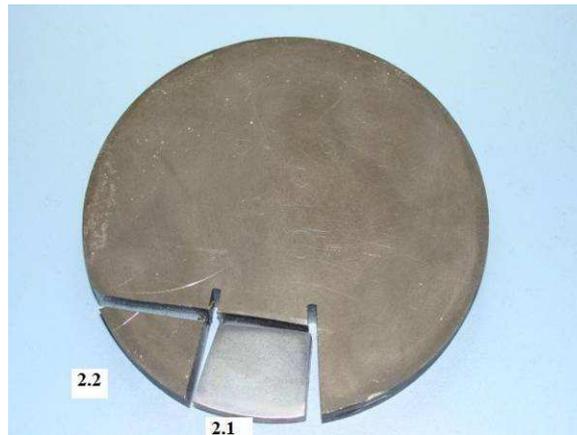
**Characterization of material microstructure in the adjacent area of breaking surface** was performed on the sample 2.1, figure 11.

*Fig. 11. Transversal cutting disc from shaft near the surface rupture*

Images from figure 12 – 15, are images of secondary electrons, presents the material microstructure obtained on the sample 2.1, from figure 11. The existence of MnS inclusions unevenly distributed in the material is remarkable, on the ferrite-perllite microstructure background. Unfavorable to its mechanical properties, these inclusions are typically grouped in discontinuous networks. We observed also the rows of MnS inclusions existence, which arrive in the axle shaft surface. Such marginal inclusions may be percussion break of those parts that are in service, rows of inclusions that emerge in the area are preferred regions of propagation and development of microcracks.
