EFFECT ON CORROSION BEHAVIOR OF COLLAGEN FILM/FIBER COATED AZ31 MAGNESIUM ALLOY

Keywords: Mg alloys, Collagen, dip-coating, Electrospinning

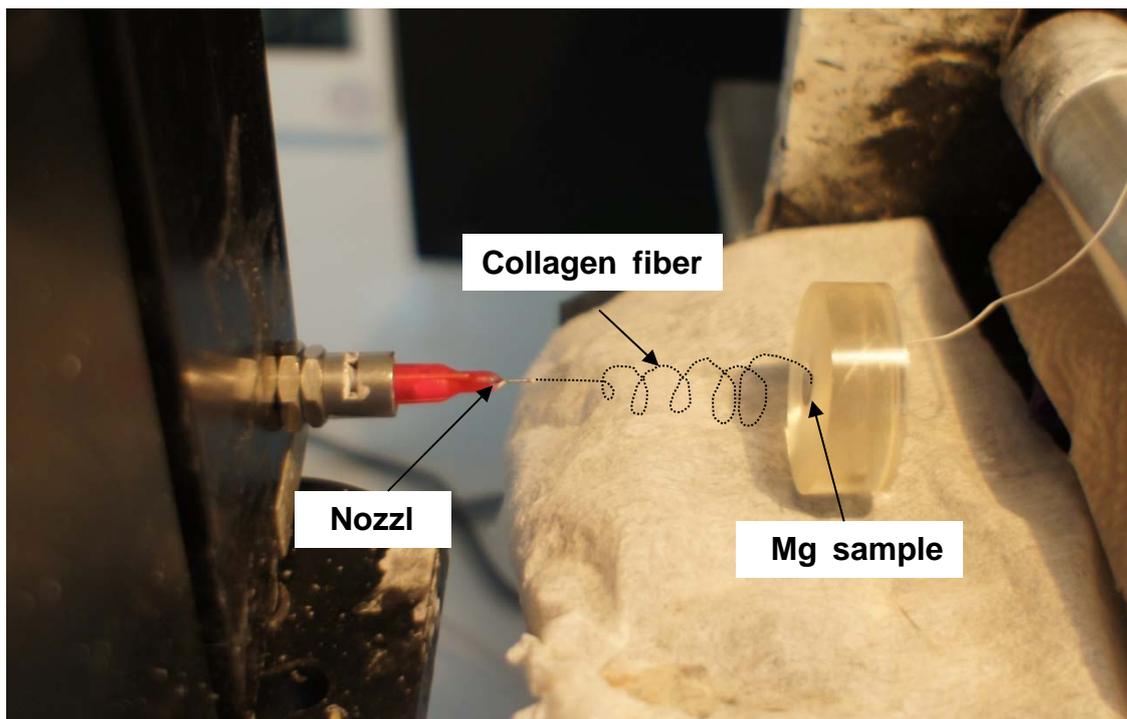
Fig. 1. Photograph of electrospin-coating on AZ31 Mg alloy.

Dip-coating and electrospin-coating were carried out using 8 wt% collagen solution in HFP. Dip-coating was carried out by simply dipping the alloy into the polymer solution for 30 seconds and dried at room temperature for 1 h. Electrospin-coating was carried out by direct collecting the fibers on the surface of specimen as shown in Fig. 1. For this propose, polymer solution was fed through the metal capillary (nozzle) having $d_i = 0.21$ mm (21 G) attached to a 1-D robot-system that moves laterally controlled by LabVIEW 9.0 program (National Instrument) [13]. The flow rate was maintained at 1 ml/h using syringe pump. Electrospinning was carried out at 20 kV applied voltage and 10 cm working distance between specimen collectors and tip of the nozzle. After vacuum dried for 24 h, the coated specimen was used for further analysis.

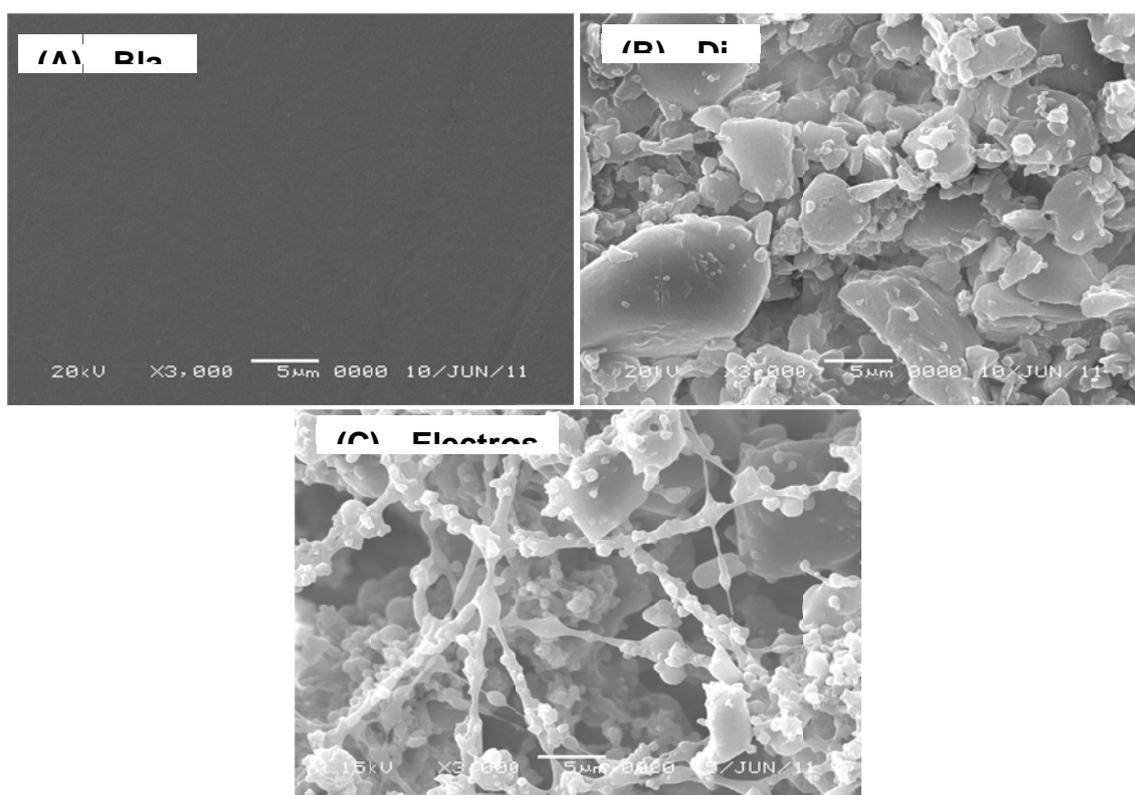
Fig. 2. SEM images of (a) blank AZ31 Mg alloy, (b) deep coated alloy, and (c) electrospinning coated alloy.

The surface morphology of blank and coated AZ31 alloy was observed using SEM images. Figure 2(a) is the SEM image of uncoated (blank Mg) sample whereas Fig. 2(b) and 2(c) are the SEM images of collagen coated surface morphology of Mg alloys using dipping and electrospinning process, respectively. As shown in Fig. 2(a), the surface of uncoated Mg alloy is smooth where as membrane-coated magnesium disk alloys show the presence of collagen

micro/nano structure on their surface. The surface roughness of Mg alloy was greatly increased after polymer coating. Compared to dip-coating, electrospin-coating could form smaller collagen particles/fibers on the surface of Mg alloy. Collagen fibers with sufficient beads were clearly seen on the surface of alloy (Fig. 2c). Since collagen has poor electrospinnability, its fiber with good morphology is difficult to obtain. Furthermore, short working distance between nozzle-tip and collector Mg alloy disk was applied here to prevent the loss of expensive collagen during coating. At short working distance, the complete evaporation of solvent is impossible and beaded fibers should be formed. The non-woven collagen fibers coated Mg alloy will be able to generate three dimensional micro-sized porous structures. This mesh consists of fibers with diameters ranging from 90- 700 nm and most of the fiber diameters are less than 400 nm. The proper attachment of collagen layer should be essential for stable coating to decrease the corrosion rate of Mg alloy. Direct electrospin-coating in high applied voltage definitely formed properly attached polymer molecules on the surface of substrate compared to the dip-coating. Generally, it is considered that polymer coating on the surface of substrate contain three different layers: the primer, intermediate, and top-coating layers [15, 16]. The first is responsible for enhancing the adhesion of the other layers to the substrate surface as well as corrosion protection. Since electrospin-coating could provide higher adhesion of first layer (due to electric field) compared to the dip-coating method, we believe that corrosion resistance of electrospin-coating should be better than that of dip-coating. It is the property of electrospun fibers to provide the highly porous network to the substrate which is not only beneficial for cell adhesion and proliferation but also for nutrient supply to the newly formed cells during tissue regeneration. Therefore, coating of Mg surface using electrospinning is superior to the dip-coating to enhance the biocompatibility of implanted scaffold.

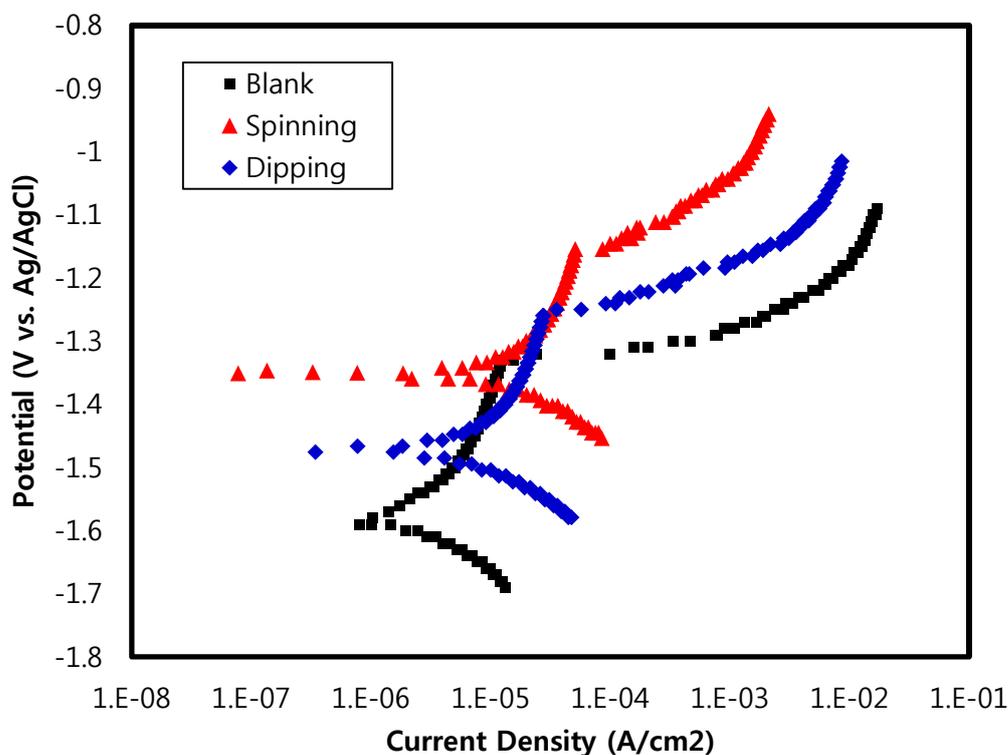
Fig. 3. Potentiodynamic polarization curves of collagen coated AZ31 Mg alloys using different coating method in Hank's balanced salt solution.

Representative potentiodynamic polarization curves obtained from the un-coated and coated AZ31 magnesium samples in SBF solution are presented in Fig. 3. The corrosion potential

(E_{corr}) showed that the polymer-coated magnesium alloys shifted the open circuit potential to a more positive potential. It is clear from Fig. 3 that AZ31 alloy coated with electrospun collagen fibers has the highest E_{corr} value and its corrosion current (I_{corr}) is also the lowest among the samples. It is well known that corrosion current density (I_{corr}) means the corrosion rate of the materials. Lower the value of I_{corr} , higher will be the corrosion resistance of the specimen. Therefore, both the E_{corr} and I_{corr} showed that the electrospun-coated sample was able to enhance the corrosion resistance of magnesium alloy.

Natural corrosion current I_{corr} and natural corrosion potentials E_{corr} were determined by Tafel method, and the calculated values are listed in Table 1. The corrosion potential (E_{corr}), corrosion current density (I_{corr}), and the anodic and cathodic Tafel slopes (β_a and β_b) were acquired from the potentiodynamic polarization curves of Fig. 3. R_p is coating resistance which

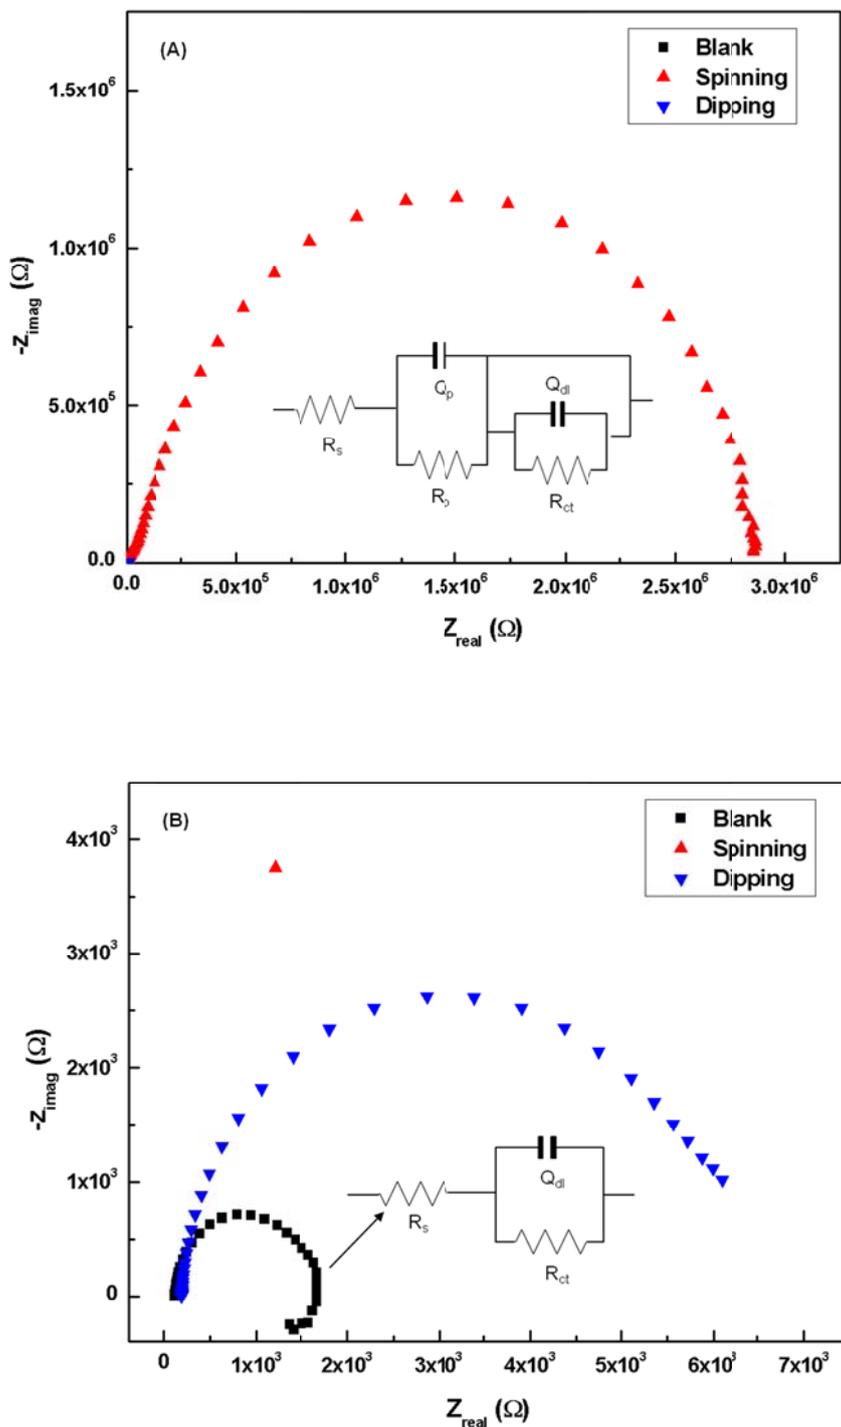
Fig. 4 Nyquist plot of collagen coated AZ31 Mg alloys using different coating method in Hank's balanced salt solution with corresponding equivalent circuits.

Furthermore, Nyquist plots can reflect a direct comparison of the corrosion resistance of AZ31 magnesium alloy coated with polymer film or fibers. Figure 4 shows Nyquist plot of collagen coated and uncoated AZ31 Mg alloy samples in Hank's balanced salt solution. EIS data were fitted with the modified Randles circuit using Gamry Echem Analyst software where R_p means the resistance of the coated collagen layer. Here, R_p of AZ31 magnesium alloy coated with electrospun fibers is the highest among the samples. The better corrosion resistance of AZ31 magnesium alloy coated with electrospun fibers is attributed to the layer-by-layer deposited collagen fibers which are effectively attached on the surface of AZ31 alloy. The proper attachment of fibers on the surface of AZ31 alloy on high applied voltage during electrospinning not only increase the corrosion resistance of AZ31 magnesium when it is used as bone implant but also provides highly porous structure of fibers with open morphology that can assist better ability of formation of new bone. Furthermore, fiber coated AZ31 alloys could maintain the mechanical strength of magnesium alloy during the initial days of implantation because it can prevent the rate of formation of magnesium hydroxide obtained from the given reaction [17].

was measured from Nyquist plots fitted with the modified Randles circuit as well. Corrosion resistance of three samples were analyzed by EIS spectra and presented in Nyquist mode. Corresponding equivalent circuits for data fitting were developed and schematically inserted in EIS plot (Fig. 4).

For the collagen coated AZ31 Mg alloy (Fig. 4(A)) a model of Rs (Qdl Rct) (Qp Rp) was employed to fit the data, where Rp and Qp are identified as the resistance and capacitance pertaining to the collagen coating, respectively. The EIS response of blank AZ31 Mg alloy can be fitted with one time constant (Fig. 4(B)), and modeled with the following components in series with a parallel circuit consisting of Rct and Qdl, the reaction resistance associated with interfacial charge transfer reaction process and capacitance associated with the electrolyte double layer established at the interface, respectively. The Rp value of the electrospin-coated Mg alloy stent is highest in magnitude among the samples. It means that impeding effect on corrosion of the AZ31 mg alloy under the protection of the collagen coating can act as an ion-conducting barrier. All EIS analysis of the electrochemical corrosion test suggested that the collagen electrospin-coating has a superior protective effect on AZ31 mg alloy in terms of corrosion resistance compared to the dipping method.

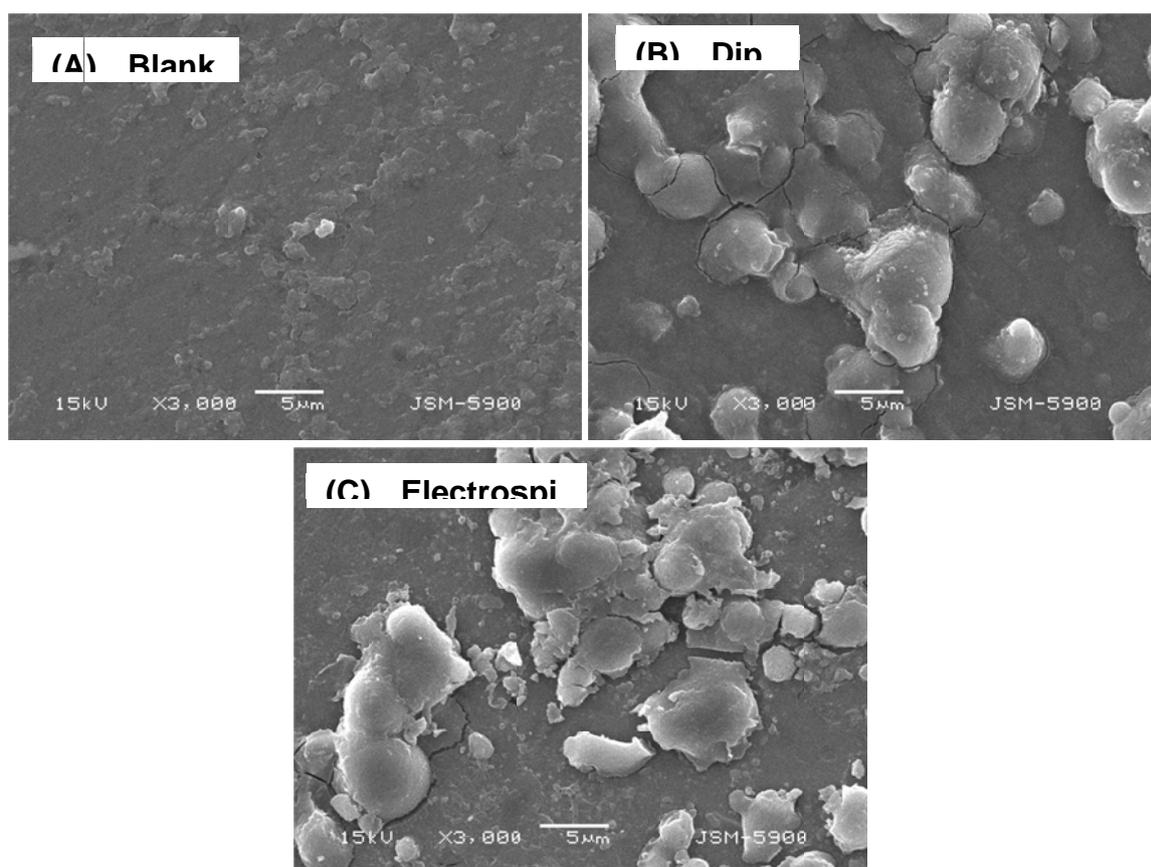
Fig. 5. SEM images of (a) blank AZ31 Mg alloy, (b) dip-coated alloy, and (c) electrospinning coated alloy after EIS test.

After EIS test, we observed the surface morphology of different samples using SEM images. It is observed from the SEM images that calcium phosphate particles were deposited on

the surface of different specimens (Fig.5). Figure 5(b) and 6(c) clearly shows that cracks are present on the surface of collagen coated specimens and the surface cracking is more pronounced in dip-coated specimen compared to the electrospin-coated specimen. The cracking of the surface might be resulted from the evolution of hydrogen gas. Since electrospinning coating has highly porous network, less cracking was observed compared to the dip-coated spacemen.
